# RESEARCH MEMORANDUM

ADDITIONAL EXPERIMENTAL HEAT-TRANSFER AND DURABILITY

By Eugene F. Schum

# NATIONAL ADVISORY COMMITTEE FOR AERONAUTICS

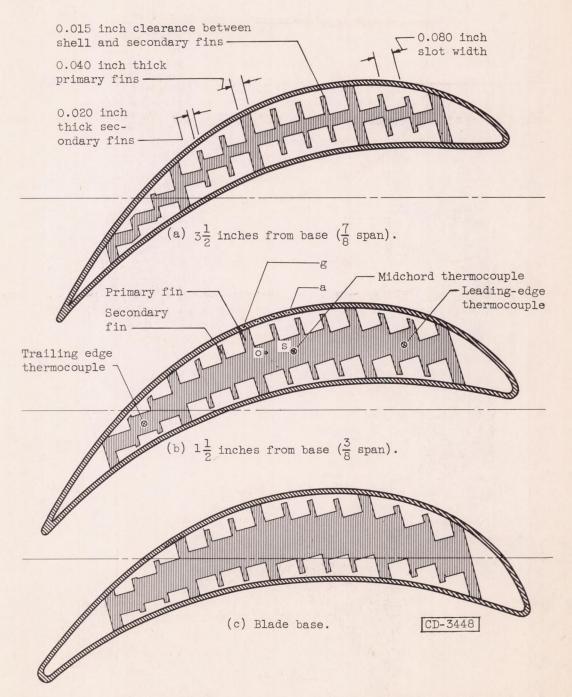
primarily attributed to space limitations in the trailing-edge region. As can be seen in figure 2, the primary and secondary fins in this region are of relatively short length which tends to reduce the cooling effectiveness of the strut and thereby to increase strut temperatures.

Figure 2. - Profiles of twisted-airfoil, strut-supported blade at three spanwise positions showing pertinent blade dimensions and locations of thermocouples and points for temperature analysis.

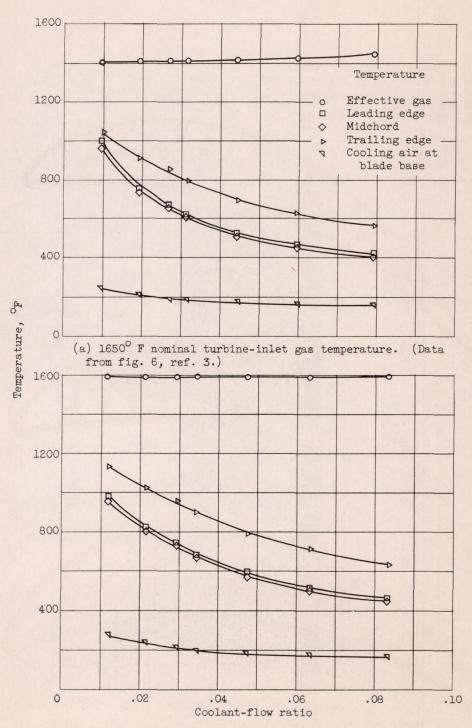
Experimental blade-temperature distribution. - Strut temperature variations measured at the leading-edge, midchord, and trailing-edge regions of the strut are shown in figure 3. The data presented were obtained at the 3/8 span position for a range of coolant-flow ratios and for two nominal turbine-inlet gas temperatures of 1650° and 1815° F (corresponding nominal effective gas temperatures of 1425° and 1590° F, respectively). Engine speed for these data was 11,500 rpm, which is equivalent to a turbine tip speed of 1300 feet per second. The variation of the coolant temperature measured at the blade base is also shown. The data shown for the lower gas temperature are the same as those shown in figure 6 of reference 3, but are included herein for comparison with the data obtained at the higher gas temperature.

Figure 3. - Variation of experimental strut temperatures of air-cooled, strut-supported blade at 3/8 span with coolant-flow ratio at 11,500 rpm for nominal turbine-inlet gas temperatures of 1650° and 1815° F. (Measured effective gas temperature and cooling-air temperature at blade base are also shown.)

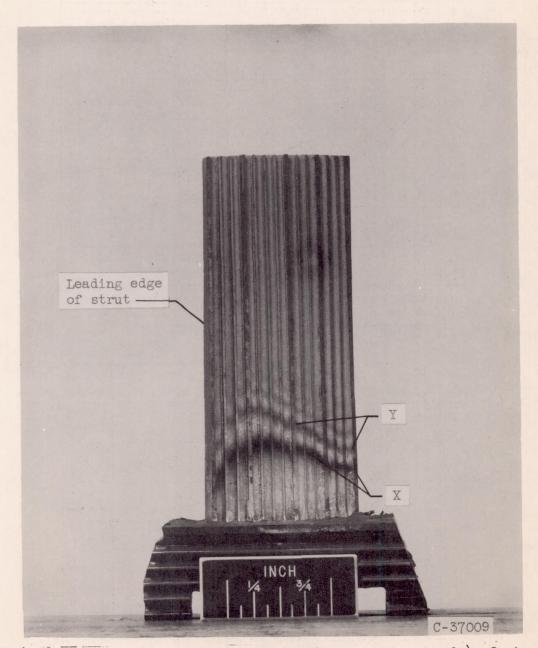
An indication of the chordwise strut-temperature distribution near the blade base may be obtained from a photograph of a blade shown in figure 4; the blade shell was removed after operation at an engine speed of 11,500 rpm and a turbine-inlet temperature of 1650° F. The heavy lines on the strut are bands of temper color. (A temper color band on a metal surface is a colored area or line caused by oxide formation at a specific temperature.) For a given material, say the strut material, the color of the lines is dependent upon the imposed strut temperature that occurs during engine operation. A photograph of a blade in which only the lines of a given color were shown would indicate the isothermal lines. Line X of figure 4 is a typical isothermal line resulting from engine operation at a given value of coolant-flow ratio. For a larger coolant-flow ratio, greater cooling of the strut is obtained and the isothermal line occurs at a greater radial location, as line Y indicates. The temperature indicated by line X is identical to that indicated by line Y. It is therefore apparent that each separate line along the blade span is a temper line for a different coolant-flow ratio. These separate lines of constant temperature that occur along the blade span are relatively flat in the midchord region, thus indicating that there is a small temperature gradient at this location. This verifies the basic assumption made in reference 4 for the calculation of strut blade temperatures.

Figure 4. - Constant temperature lines (temper color bands) of strutsupported blade after heat-transfer tests.

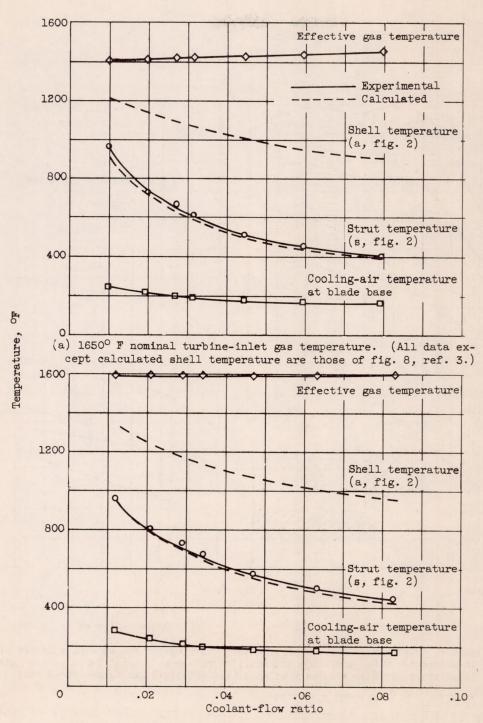
Comparison of calculated and experimental midchord strut temperatures. - A comparison of calculated and experimentally obtained midchord strut temperatures at the blade 3/8-span location is shown in figure 5. The calculated and experimental midchord strut temperatures and calculated midchord shell temperatures are presented for two nominal turbine-inlet gas temperatures of 1650° and 1815° F (corresponding to nominal effective gas temperatures of 1425° and 1590° F, respectively) for a range of coolant-flow ratios. The calculated and experimental strut

For both values of turbine-inlet gas temperature, favorable agreement was obtained between the calculated and experimental midchord strut temperatures, the difference being of the order of 20° F. With an increase of gas temperature from 1650° to 1815° F, a large change in the factors affecting heat-transfer (such as gas-to-blade heat-transfer coefficient) was not expected. The favorable agreement shown in figure 5(b), however, does provide additional verification of the method of calculating blade temperatures for strut-supported blades.

Figure 5. - Comparison of calculated and experimental midchord strut and shell temperatures at 3/8 span for range of coolant-flow ratios. Comparison made for nominal turbine-inlet gas temperatures of 1650°F and 1815°F for engine speed of 11,500 rpm. Cooling-air temperature at blade base also shown.

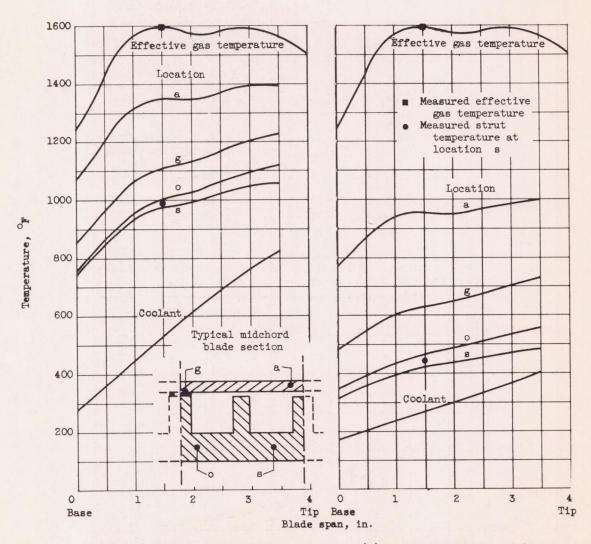
Figure 6. - Calculated spanwise temperature distribution for several midchord blade locations for 0.012 and 0.084 coolant-flow ratios at nominal turbine-inlet gas temperature of 1815° F. Measured strut and effective gas temperatures at 3/8 span  $(1\frac{1}{2}$  in. from base) also shown.

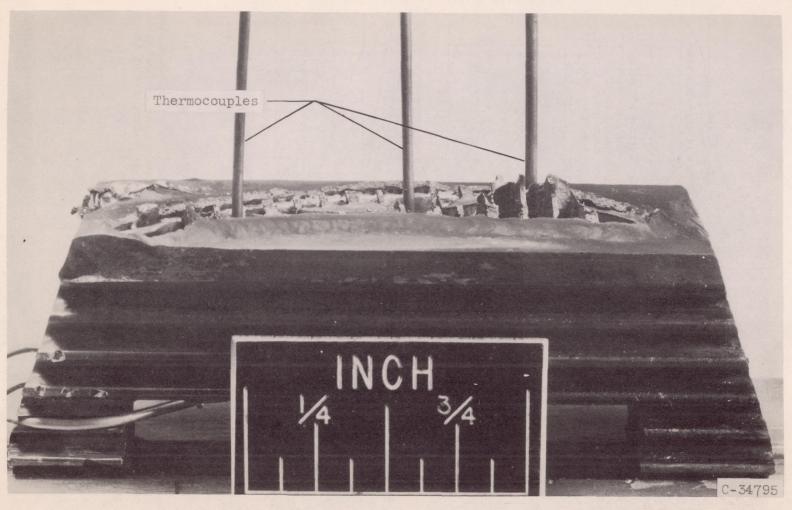
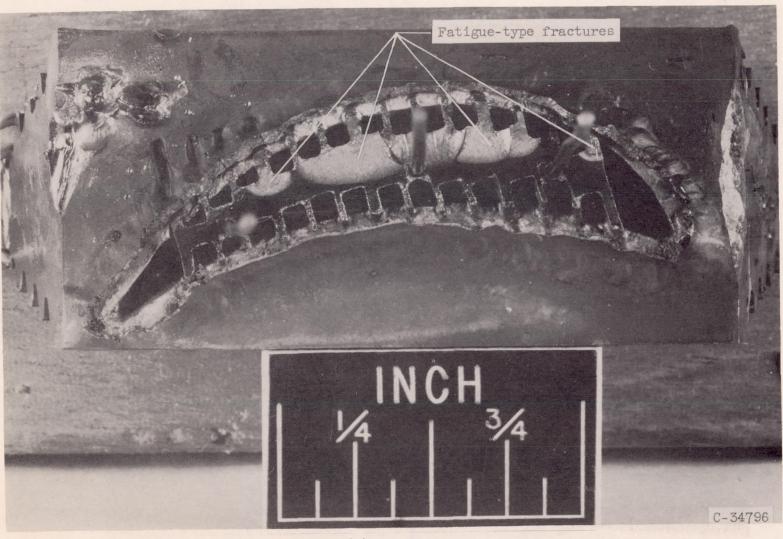
Strut blade 1. - This blade was given heat treatment A (table II) which consisted of a 1-hour normalizing at 1725° F and a 4-hour temper at 1225° F. During both these furnace treatments, the blade was protected from oxidation by immersion in an argon atmosphere. This heat treatment was selected because of the resulting high stress-to-rupture strength that is obtainable. After 2 hours and 29 minutes operation at a low coolant-flow ratio of 0.01, a failure occurred in the strut at the junction of the strut and the blade base. A photograph of the blade after the failure is shown in figure 7. Examination of the blade base to ascertain the cause of the failure indicated a fatigue-type fracture, as evidenced by the light, semicircular areas of the strut shown in figure 7(b). It was observed that the fatigue cracks originated on the suction surface of the blade and progressed toward the center of the strut until a tensile failure caused a complete strut rupture. A metallurgical examination of the blade after failure indicated that the cracks originated at approximately the same time, which shows that the stresses in the strut are fairly uniformly distributed. The calculated centrifugal stress imposed on the strut at this blade location was 44,000 pounds per square inch. The nature of the failure denoted that the strut material did not have sufficient ductility to withstand the combination of the imposed vibratory stresses, centrifugal stresses, and stress concentrations caused by the notches in the fillet region of the blade.

Figure 7. - Failure of strut blade 1.

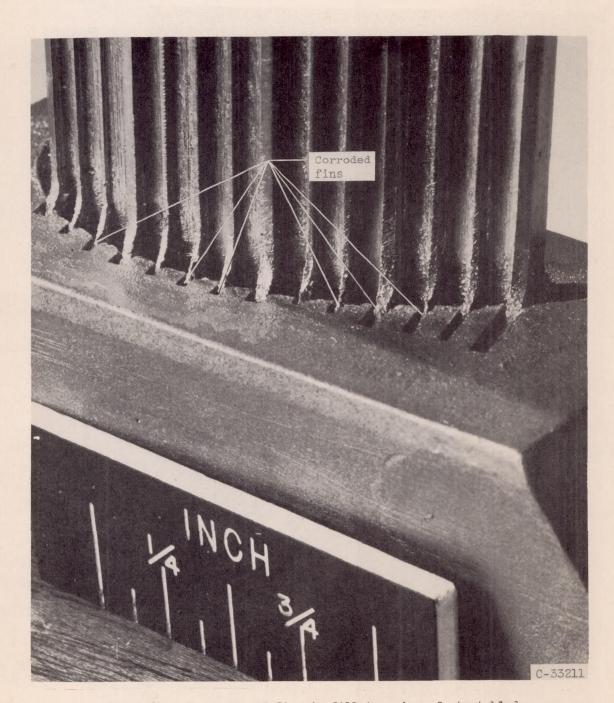
Figure 8. - Corrosion of fins in fillet region of strut blade.

In the design of strut-type blades, effort should also be made to reduce the notch effect in the fillet region of the blade; the notches in conjunction with a nonductile type of material are thought to be the primary cause of the blade failures reported herein. Generous fillets and a tempering temperature resulting in good ductility should be used when possible.

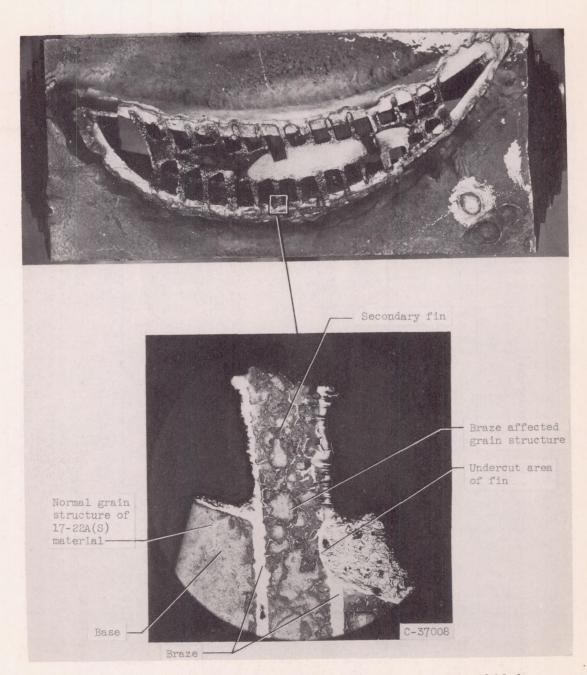
on blade life than was thought earlier. Blades 1 and 2 were subjected to four and three brazing cycles, respectively, because of the fabrication problems discussed earlier in the description of the blades. The corrosive action of the braze on the strut fins in the fillet region of a strut blade which has been subjected to several braze cycles is shown in figure 8. The figure indicates where the thickness of the fins has been reduced by the corrosive action of the braze. Successive cycles also increased braze diffusion into the strut material, causing a brittle and notch-sensitive material.

The extent of braze penetration into a typical 0.020-inch secondary fin of strut blade 2 determined from a microscopic examination of a square section of the blade removed after failure is shown in figure 9. The enlarged view is a section where the secondary fin is brazed into the blade base. The normal grain structure of the 17-22A(S) material and the braze-affected grain structure of the secondary fin can be readily seen. Complete intergranular diffusion of the braze material through the fin shown in figure 9 was observed in many other secondary and primary fins (0.040 in. thickness). It is believed that the large grain size in conjunction with braze diffusion is conducive to fatigue-type failures (ref. 6). Severe undercutting of the fin by the braze material also occurred (see fig. 9). Similar undercutting and diffusion was also evidenced in a durability investigation of a tube-filled, shell-supported blade (ref. 6).

Figure 9. - Microstructure (40% size) of section of strut fin and blade base showing extent of braze penetration for strut blade 2.

During each braze cycle, blades 1 to 4 were subjected to a temperature of 2150° F for 15 minutes and temperatures above 1850° F for approximately 2 hours. During this period considerable diffusion can occur. This relatively long duration above 1850° F was required because of the limitation of the heating capacity of the furnace that was used. Blades 5 and 6 were both brazed in a hydrogen furnace. The duration of each braze cycle at elevated temperatures for these two blades was much less than the 2 hours required for blades 1 to 4. A metallurgical examination of blade 6 after failure showed that the braze penetration was less than that for blades 1 to 4, inclusive. An examination of blade 5 was not made, although the braze penetration should compare with that for blade 6. It is believed that the favorable life of blade 5, as compared with blades 1 and 3 which were operated at the same coolant-flow ratio of 0.01, is caused by this reduced braze penetration. Diffusion of the braze into the strut material can probably be further reduced by the use of a more rapid cycle obtained from an induction heating element located inside the furnace. Another possible means of eliminating the braze diffusion problem in the base region of the strut is to cast the strut integrally with the blade base and thereby eliminate the brazing cycle that is normally required for this operation.

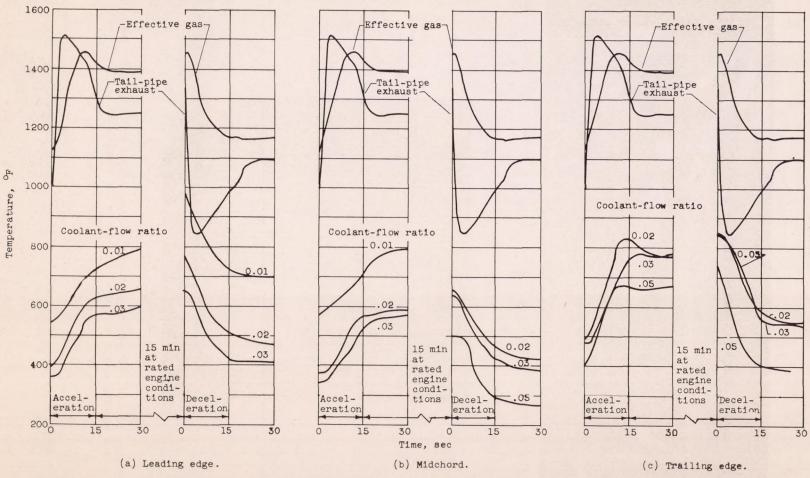
Figure 10. - Variation of effective gas. tail-pipe exhaust, and strut temperatures experimentally obtained during cyclic endurance investigations. Values of leading-edge, midchord, and trailing-edge strut temperatures snown for several coolant-flow ratios.
